# **Winans Lake Drainage Problems and Solutions**

## **Winans Lake Association – Stormwater Sedimentation Reduction Committee**

**2/18/2022**

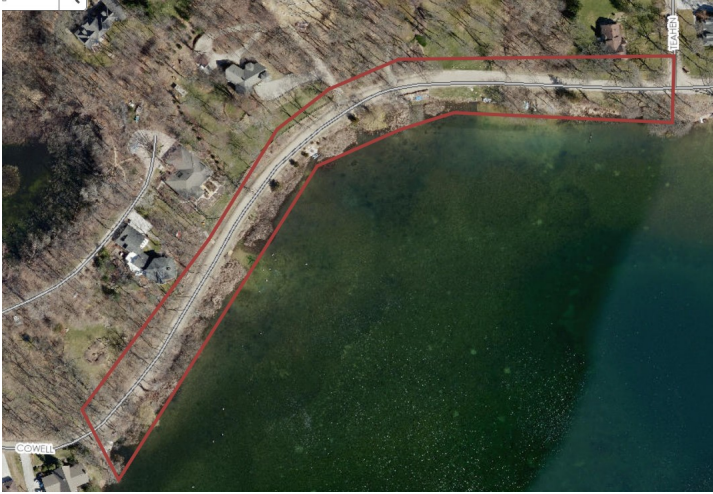
**Location:** Cowell Rd. west of Teahen Rd. to curve

Stormwater from several sources converges along this stretch of Cowell which erodes the surfaces and shoulders of Cowell and Teahen roads and deposits large quantities of sediment/pollutants into Winans Lake directly and through drain pipes.

- Significant stormwater/sediment/pollutants flow south down Teahen to Cowell, causing erosion of road surfaces and shoulders and sedimentation into the lake.
- Stormwater flows out of Winans Woods Retention Pond#5 south across Old Drive, south across the property of 5824 (Old) Cowell Rd to Cowell Rd. at the curve causing erosion of road surfaces and shoulders and sedimentation into the lake.
- Stormwater flows east down Cowell from Chilson causing erosion of road surfaces and shoulders and sedimentation into the lake.

- Harden the surface, shoulders and ditches of Cowell Rd. (e.g. paving, limestone, etc.)
- Complete and improve the ditching along Cowell Rd. with sediment traps with regular maintenance.
- Install structures and pipes underground to convey majority of water underground similar to preliminary solution presented by Wade Trim for Teahen Road.
- Install settling structure prior to existing drain outfall on north side of Cowell.

- Install settling structure in the lake enclosing existing drain pipe outflow to be maintained with regular excavation and nutrient neutralization.
- Install underdrains to flow clean perched water south under Cowell Rd. toward lake.
- Install Sedimentation barriers between south side of Cowell and Winans lake.

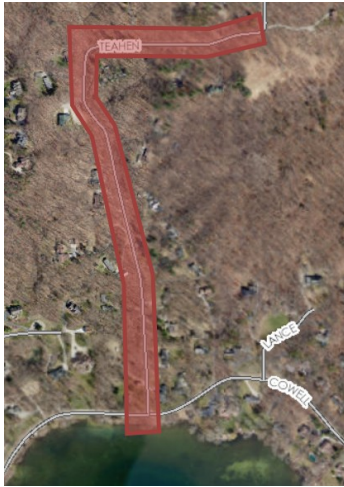
**Location:** Teahen Rd. north of Cowell

Unmanaged stormwater flows down Teahen, erodes the surfaces and shoulders of Teahen, and contributes large quantities of stormwater and sediment to Cowell west of Teahen, which ultimately contributes large quantities of sediment/pollutants into Winans Lake directly along Cowell and through existing drain pipe.

- Significant stormwater/sediment/pollutants flow south down Teahen to Cowell, causing erosion of road surfaces and shoulders and sedimentation into the lake along Cowell.

- Harden surface, shoulders and ditches of Teahen Rd. (e.g. limestone, etc.)
- Complete ditching along Teahen Rd.
- Install structures and pipes underground to convey majority of water underground according to preliminary solution presented by Wade Trim.
- Install settling structures/ponds/trap(s) on sides of Teahen to capture sediment and then outlet clean water into Winans Lake via pipe or ditching along Teahen/Cowell.
- Install settling structures/ponds/trap(s) between Cowell Rd. and Winans Lk at/near Teahen.
- Install culvert running east-west under Teahen at Cowell.

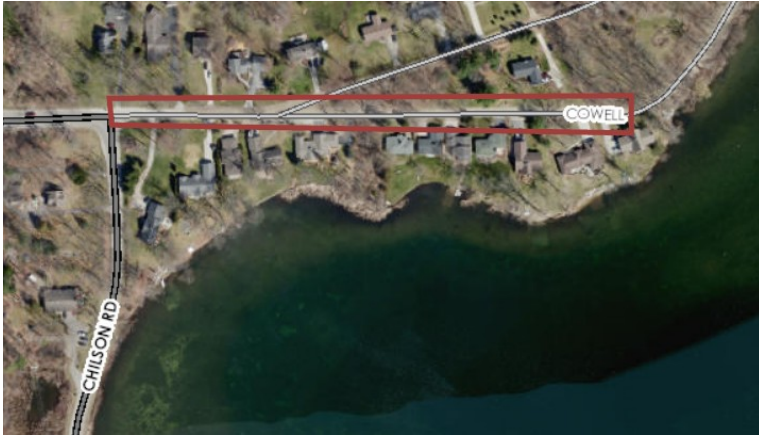
**Location:** Cowell Rd. west of curve to Chilson Rd.

- Stormwater flows east down Cowell from Chilson causing erosion of road surfaces and shoulders and contributes significant stormwater, erosion and sediment to Cowell east of the curve, which eventually enters the lake directly from along Cowell or through the existing pipe outfall into the lake.
- Flooding of basements at 5880 and 5890 Cowell.
- Flooding of driveways along Cowell.

- Stormwater flows east down Cowell from Chilson causing erosion of road surfaces and shoulders and sedimentation into the lake. Note: Recent changes to Cowell Rd. crown and elevation has reduced the amount of stormwater and sediment flowing east down Cowell to the curve but has caused flooding of driveways and yards.

- Harden the surface, shoulders and ditches of Cowell Rd. (e.g. paving, limestone, etc.)
- Consider installing ditching along Cowell.
- Install structures and pipes underground to convey majority of water underground similar to preliminary solution presented by Wade Trim for Teahen Road.
- Install retention pond north of Cowell.

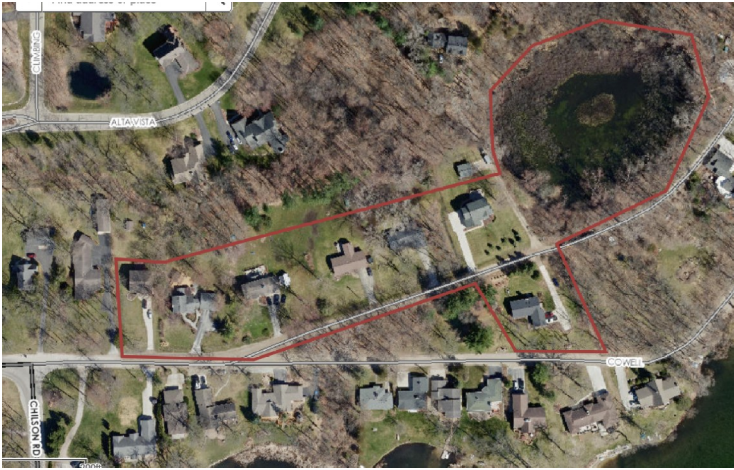
**Location:** Old Cowell (Old Drive), Winans Woods Retention Pond #5, Cowell Rd. near curve.

- Winans Woods Retention Pond #5 overflows and contributes significant stormwater to Cowell, ultimately contributing to extreme amounts of road/shoulder erosion and sedimentation into Winans Lk along Cowell from the curve to Teahen.
- Water flowing south from Winans Woods floods basements at 5824 Old Cowell, 5835 Old Cowell and causes flooding and standing water in 5-7 lots along north side of Old Cowell.

- Winans Woods Retention Pond #5 (WWRP5) not operating as designed to withstand 30 year event. Water level higher than original design intent. Moderate stormwater causes this pond to overflow, flowing water south across the property of 5824 (Old) Cowell to Cowell, which ultimately adds to other stormwater on Cowell and contributes to extreme amounts of road/shoulder erosion and sedimentation into Winans Lake along Cowell from the curve to Teahen.

- Restore the historical/planned drainage pattern to flow water west along ditches on the north side of Old Cowell ultimately discharging to the wetlands SW of Chilson or into Winans Lake via the old drain pipe(s) (clean water only). Add settling structure as required between Cowell and Old Cowell.
- Build up the elevation of Old Cowell in area of 5824 to keep overflow from WWRP5 in the ditch on N side of Old Cowell. Provide culvert for driveway at 5975 Old Cowell to direct water into existing ditch.

- Increase capacity of WWRP5 to prevent overflow (e.g. by lowering the normal water level in WWRP5 to historical level prior to Winans Woods development).
- Provide drain lines from affected properties on Old Cowell directing water from yards to existing ditch on north side of Old Cowell.
- Evaluate stormwater system within Winans Woods and repair/enhance as appropriate (e.g. defective dike in retention pond reported by residents).
- Add nutrient neutralizers to Winans Woods retention ponds.

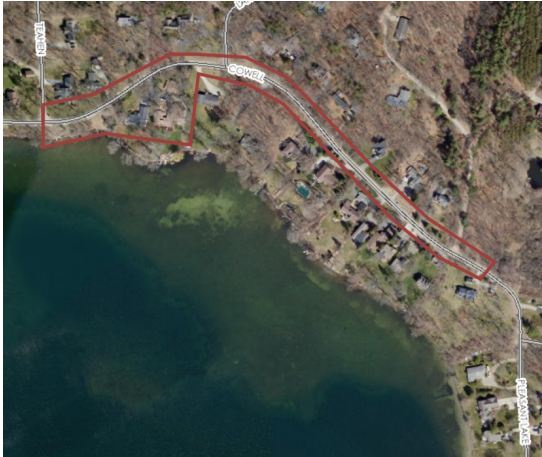
**Location:** Cowell Rd. east of Teahen to high point west of Pleasant Lake Dr.

- Stormwater and sediment flow west down Cowell from high point.
- Existing underground drain outfall discharges sediment/pollutants into Winans Lk in front of 6119 Cowell.
- Basement flooding 6130 Cowell

- Harden the surface, shoulders and ditches of Cowell Rd. (e.g. paving, limestone, etc.)
- Install retention pond south of Cowell east Teahen and west of 6135 Cowell.
- Install retention pond north of Cowell at Lance Ct.
- Install settling structure prior to outfall across from 6119 Cowell.
- Intercept/retain/settle water coming down from Lance Ct.
- Install structures and pipes underground to convey majority of water underground similar to preliminary solution presented by Wade Trim for Teahen Road.

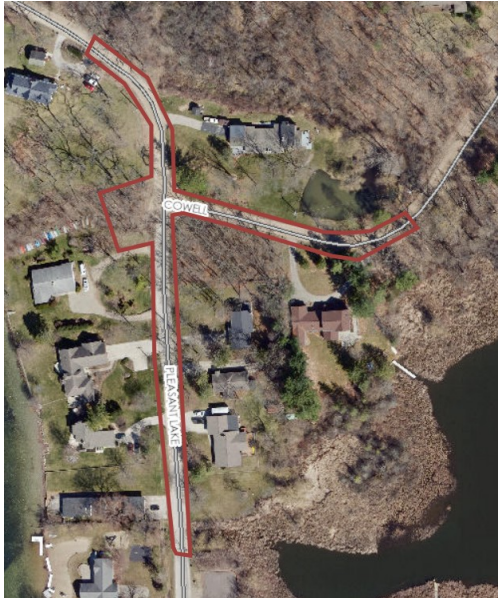
**Location:** Cowell Road near Pleasant Lake Drive

- Stormwater and sediment flow east down Cowell from high point down to Pleasant Lake Dr eroding Cowell and leaving substantial amounts of sediment on and along Pleasant Lake Dr.
- Existing improvised sediment traps at the top and bottom of curve fill up rapidly with sediment requiring constant maintenance.
- Sediment trap at bottom of curve at WLA access site frequently inundated and discharges sediment into Winans Lk.

- Harden the surface, shoulders and ditches of Cowell Rd. (e.g. paving, limestone, etc.)
- Complete ditching along Cowell Rd.
- Direct stormwater into wetland north of Cowell and east of Pleasant Lake Dr. with appropriate sedimentation removal.
- Direct stormwater in ditch from Cowell/Pleasant Lake intersection east into pond NW of Cowell then into Tamarack Lake or into Tamarack Lake directly.
- Place and maintain sedimentation structure at bottom of curve on/near WLA access site.
- Install ditch/swale along Pleasant Lake Dr. from Cowell to Tamarack Lake outlet near 8688 Pleasant Lake Dr.

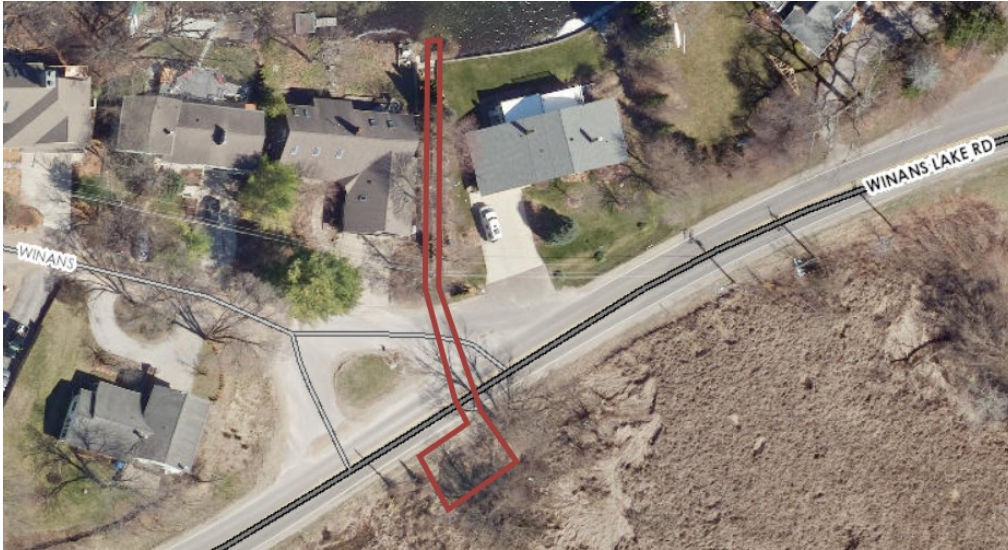
**Location:** Outlet from Winans Lake to Gut Lake, Winans Lake Rd. near Winans Dr.

- Outfall of pipe into Gut Lake Winans Lk Rd. fills in with sediment from road shoulders and surfaces of Winans Dr. and Winans Lk Rd., requiring periodic excavation.
- Outlet from Winans Lake requires periodic maintenance and restabilization.

- Harden surfaces of Winans Dr. north of Winans Lk Rd. up to high point (e.g. paving, limestone, etc.)
- Periodically excavate outfall.
- Install solid (steel, concrete, rock, ect.) walls along banks of outlet to stabilize banks and prevent erosion/collapse.

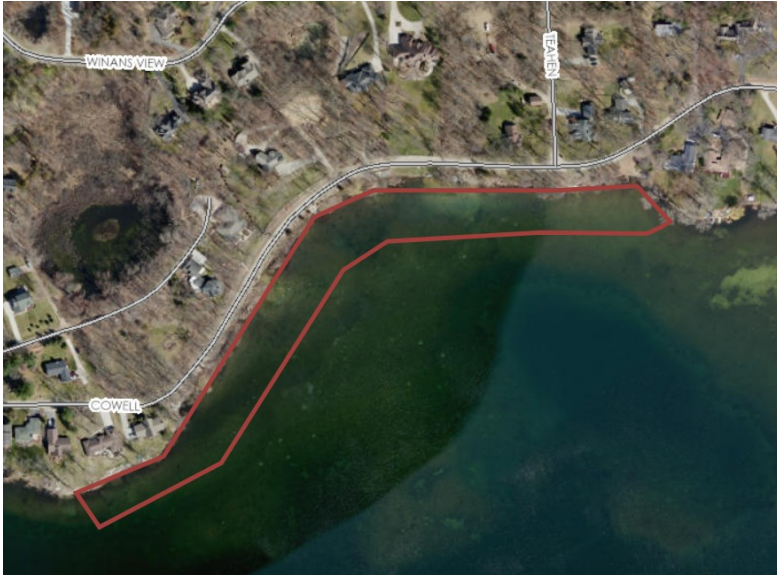
**Location:** Winans Lake bottom from approximately Teahen west to curve

- Decades of eroded sediment and road material has filled in areas of the lake, degrading access and frontage for at least 8 properties.

- Remediate by dredging material from the lake provided no significant environmental issues with contaminants.

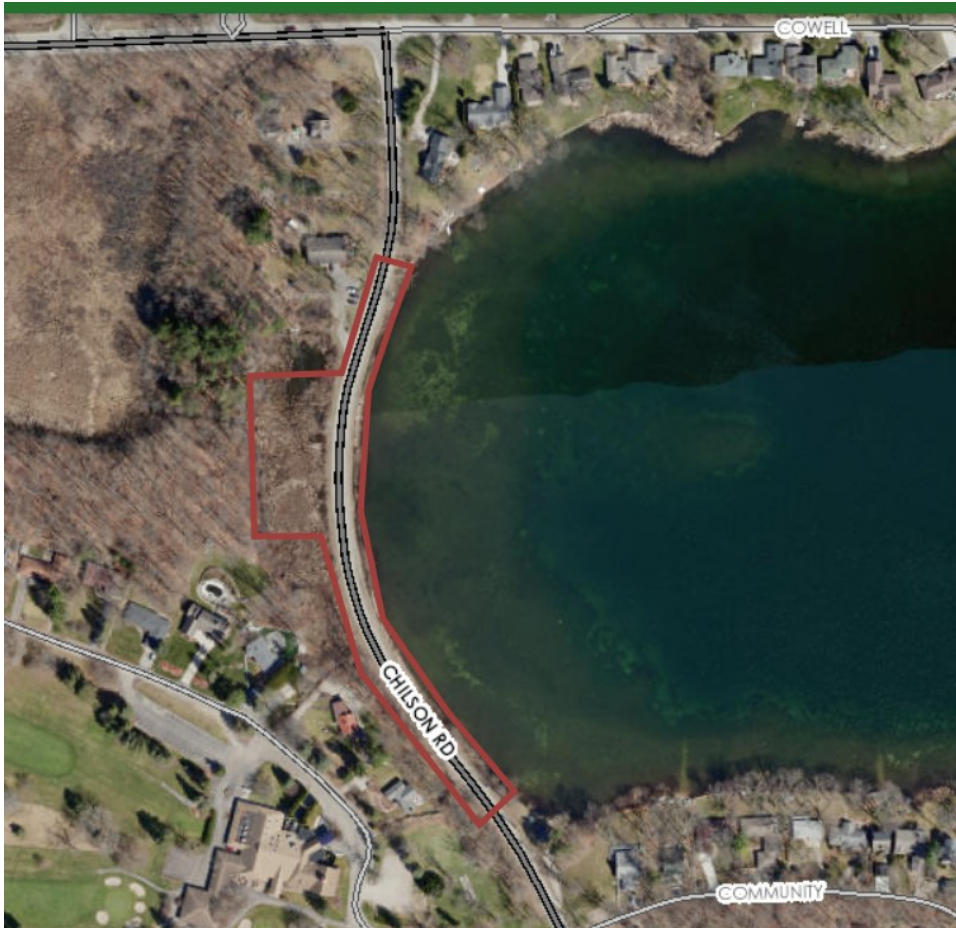
**Location:** Chilson Rd. along west shore of Winans Lake, wetlands west of Winans Lake

- Stormwater, sediment and pollutants flow east over Chilson Rd. into Winans Lake
- Wetland across from Winans Lk has filled in and no longer supports good fish spawning habitat
- Culvert pipe between Winans Lk and wetland not conducive to fish passage.

- Rehabilitate/excavate wetland to increase capacity.
- Install ditches along Chilson Rd. to direct water into wetland.
- Install larger culvert or bottomless culvert to facilitate drainage and fish passage.
- Install sedimentation barrier along west shore of Winans Lake.
- Add nutrient neutralizers to wetland.

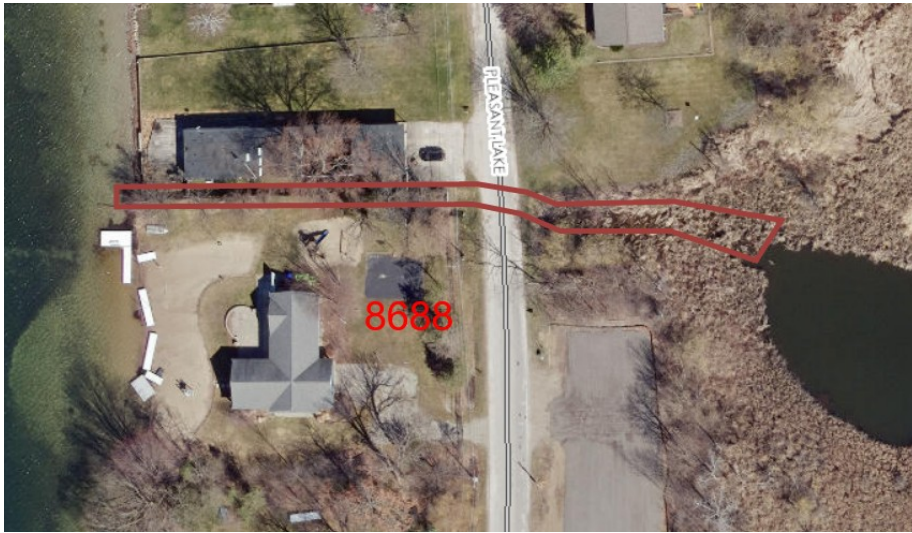
**Location:** Outlet from Tamarack Lake to Winans Lake, Pleasant Lake Dr. near 8688 (Beach House).

- Drain pipe outletting water from Tamarack Lake to Winans Lake is degraded and partially obstructed.
- Fish passage between Winans and Tamarack Lk is obstructed reducing critical fish spawning habitat.

- Repair/replace drain pipe from Pleasant Lake Dr to Winans Lake.
- Periodically clear outlet from Tamarack Lake.
